Streamflow Summary for Gaging Stations on the East Fork Lewis River, 2005-06

January 2009

Publication No. 09-03-002

Freshwater Monitoring Unit
Western Operations Section
Environmental Assessment Program
Washington State Department of Ecology
Olympia, Washington 98504-7710

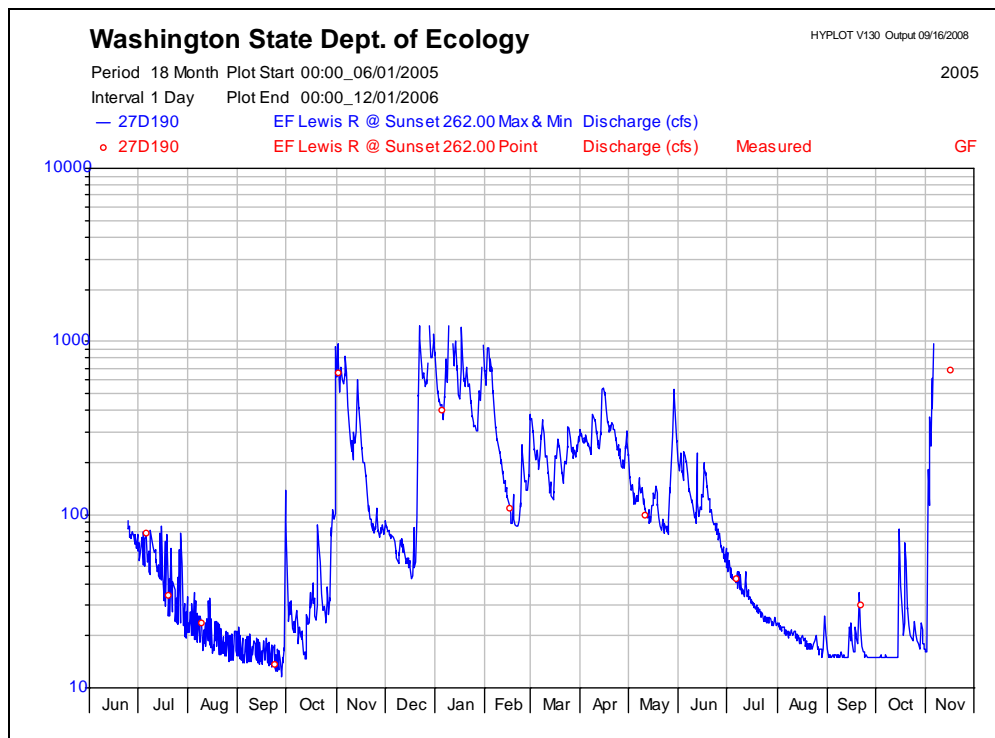
Figure 3: Discharge hydrograph for Site 2 June 1, 2005 – October 31, 2006.

The average daily discharge for Site 2 ranged from 12.7 cubic feet per second (cfs) in September 2005 to 1,000 cfs during a large storm event in January 2006. Peak streamflow during the study was greater than 1,240 cfs (Figure 3). Since high flow modeling was not done for this site, the true peak flow is not known. Daily discharge averages are presented in Appendix A. The measured range of discharge for this site encompassed less than 30% of the range of discharge encountered, with flow measurements ranging from 13.6 to 689 cfs (Figure 4). However, those flows that exceeded the measured range occurred only 5% of the time. 1% of flows were less than the lowest measured flow, and 4% of flows were higher than the highest measured flow (Figure 5).

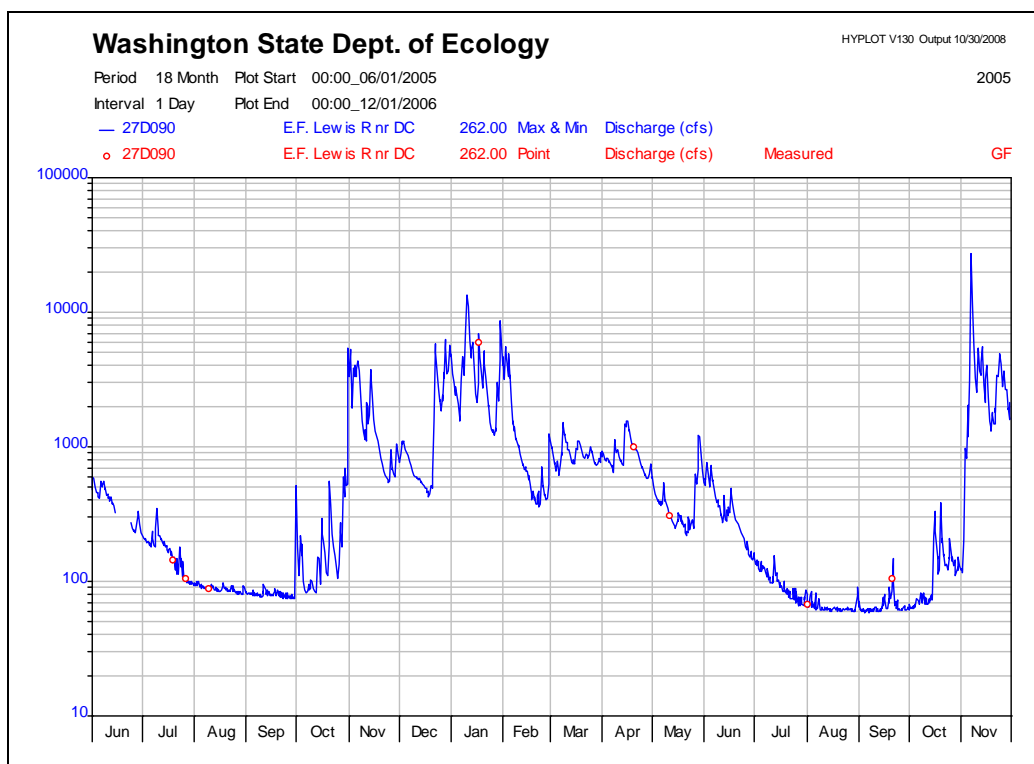
Figure 7: Discharge hydrograph for Site 3, June 1, 2005 – November 30, 2006.

The average daily discharge for Site 3 ranged from 60.6 cfs in August and September 2006 to 10,700 cfs during a large storm event in January 2006. Peak streamflow during the study is estimated to be 13,600 cfs (Figure 7). Daily discharge averages are presented in Appendix B. The measured range of discharge for this site encompassed less than 45% of the range of discharge encountered, with flow measurements ranging from 68.4 to 5,970 cfs (Figure 8). However, those flows that exceeded the measured range occurred only 12% of the time. 11% of flows were less than the lowest measured flow, and 1% of flows were higher than the highest measured flow (Figure 9).

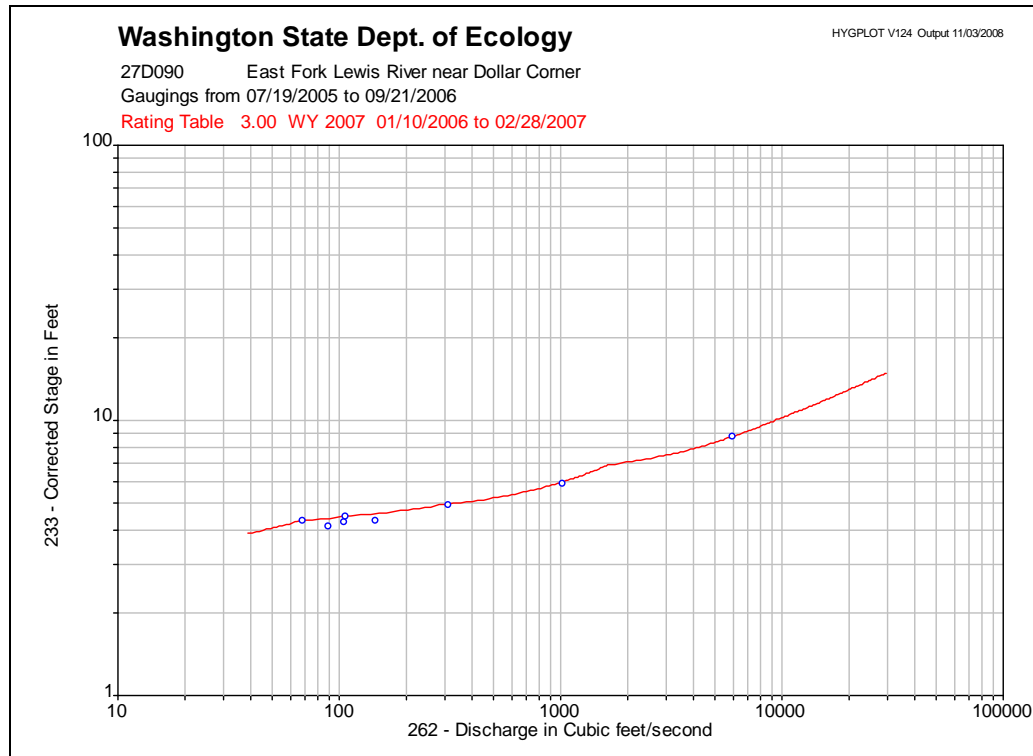
Figure 8: Discharge rating curve for Site 3, July 19, 2005 – November 30, 2006.

Within the measured range of flows, the fit of the rating curve was excellent. All 12 discharge measurements taken at Site 3 were within 5% of the flow predicted by the rating curve.

In January 2006, a large storm event (the largest of the 2005-06 study period) caused a moderate amount of fill at this site, causing a shift in the stage-discharge relationship that affected low flows. This shift was reflected in the rating curve for the site, and applied for the remainder of the study period.

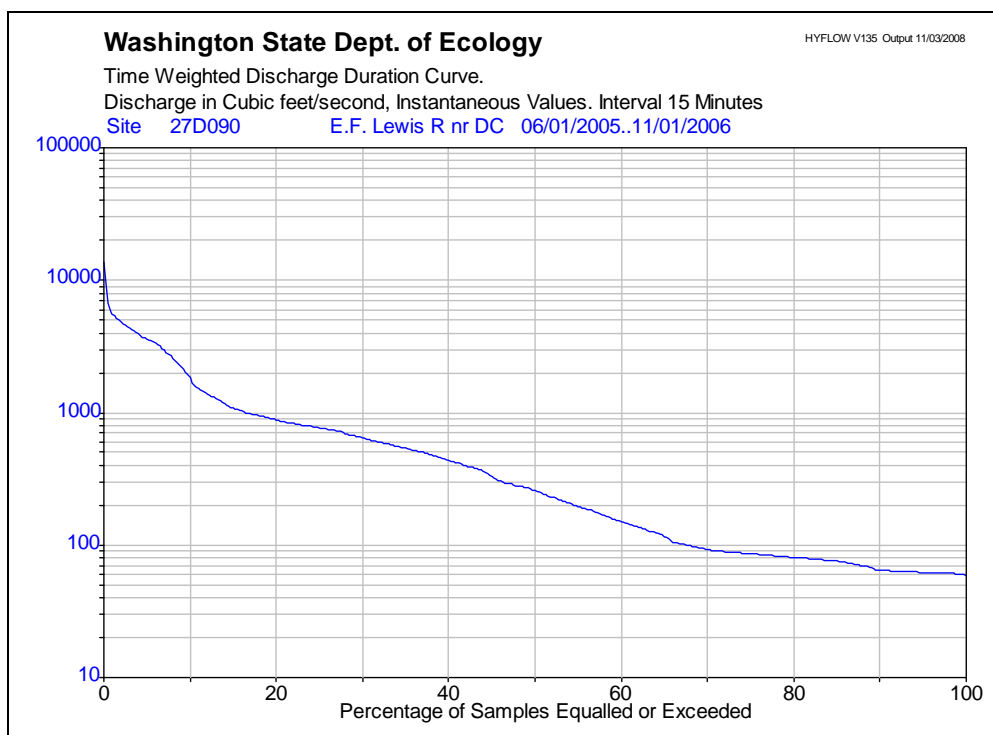
Figure 9: Discharge exceedance graph for Site 3, June 1, 2005 – November 30, 2006.
